## Safety Alert: Number SA-26-0013

| Title | Blockwork Wall Failure and Silica Exposure Risk | | | | SAFETY<br>CRITICAL<br>CATEGORY<br><br><br>Level 1 –<br>Routine |
| Location | M1 Network | | | | |

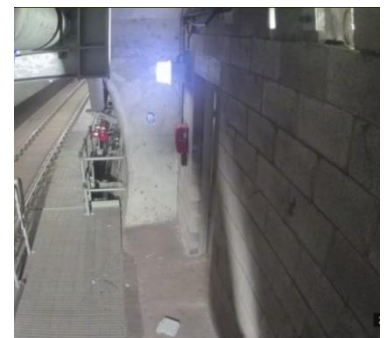
During a routine track patrol, a blockwork wall failure was identified at Cross Passage XP082. The failure was attributed to incomplete strengthening works and unsuitable connections from original construction, which allowed repeated train-induced air-pressure loads to loosen the wall.

Emergency works were undertaken to dismantle the affected wall and make the area safe.

- The affected blockwork wall has been dismantled and the area made safe.
- Inspections of the remaining blockwork walls are being completed to identify any similar defects.
- Work planning and briefing requirements are being reinforced to ensure structural condition, silica hazards and respiratory protection are addressed before work starts.
- Safety-critical corrective actions will be assigned, tracked and verified to confirm they effectively address the underlying causes.
- Silica awareness training will be rolled out to MTS workers across the business whose roles may involve exposure to, or management of, silica-related risks.
- Contractors are to review their internal procedures, SWMS, training and controls to ensure silica exposure risks are identified, communicated and effectively managed before work commences.
